**MINERALS MANAGEMENT SERVICE**

**HURRICANE ANDREW  
PLATFORM INSPECTION AND ANALYSIS**

**FINAL REPORT**

**PMB ENGINEERING INC.  
SAN FRANCISCO, CALIFORNIA**

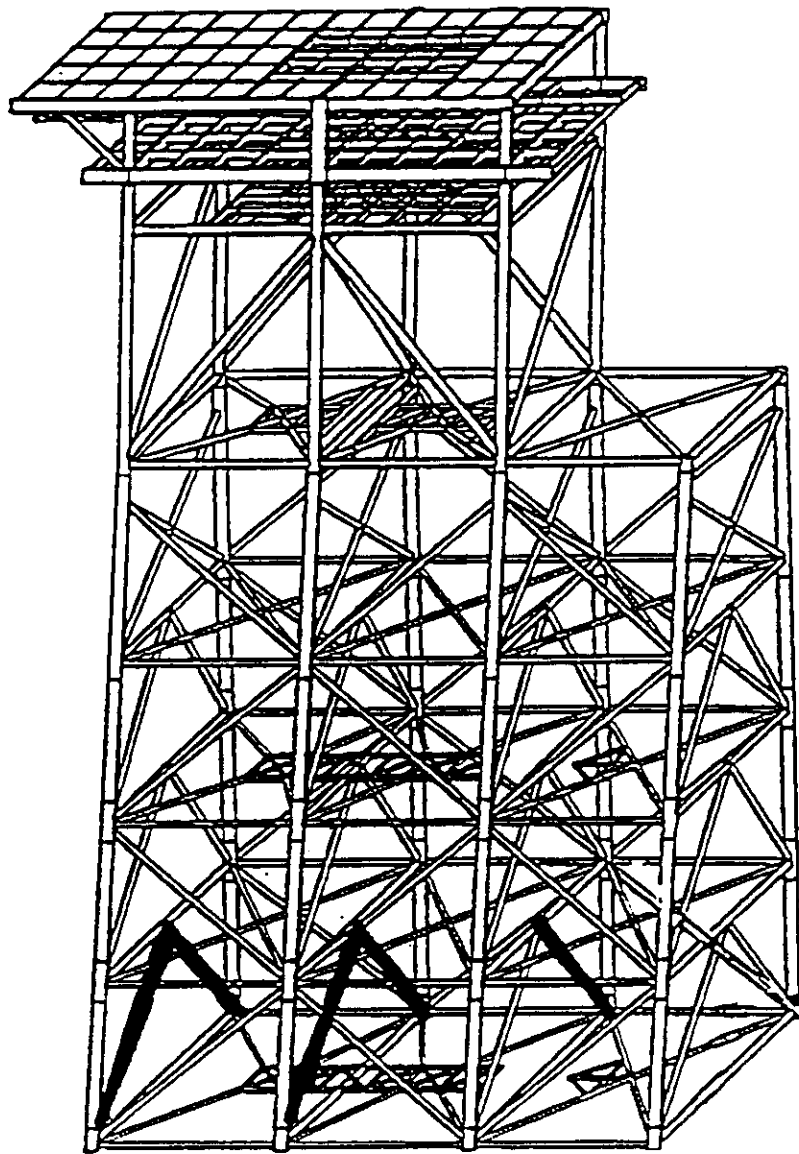
**Figure 2-1 Platform ST 130 A - Toppled in Andrew**

1. Platform ST 130 A which toppled during Andrew and had not yet been salvaged. Figure 2-1 shows the general configuration of this eight leg, 140' water depth platform. The toppled structure was still relatively intact, laying on its side, providing a good opportunity to investigate why the platform failed.

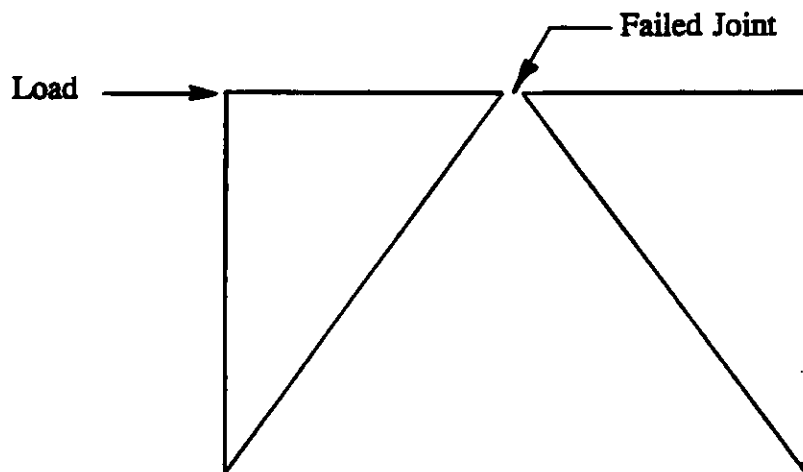
**Figure 4-2 K-Brace Joint Failure**
